PROYECTO FINAL DE CARRERA

Patología estructural y del casco:

Métodos de protección, inspección, mantenimiento y reparación

Ingeniería Naval y Oceánica
Junio, 2014

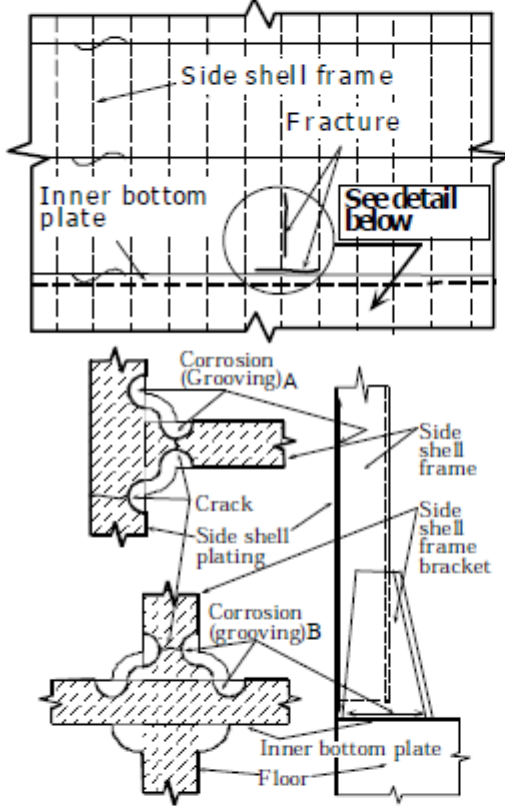
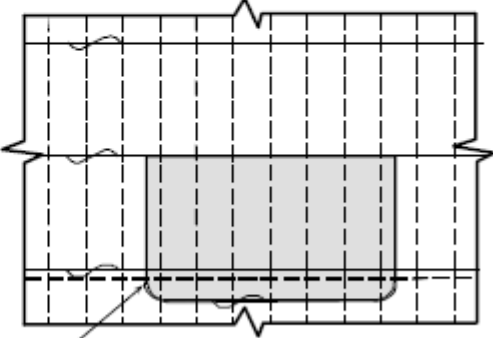
GENERAL CARGO SHIPS		Guidelines for Surveys, Assessment and Repair of Hull Structure
Part 1	Cargo hold region	Example No.
Area 2	Side structure	2
Detail of damage	Fractures in side shell frame/lower bracket and side shell plating near tank top	
Sketch of damage

Sketch of repair

Part renewal including side shell frames and inner bottom plating, as found necessary
Notes on possible cause of damage <ol style="list-style-type: none"> 1. Fracture in side shell plating along side shell frame: Heavy corrosion (grooving) along side shell frame (See A). 2. Fracture in side shell plating along tank top: Heavy corrosion (grooving) along tank top (See B) resulting detachment of side shell frame bracket from inner bottom plating. 		Notes on repairs <ol style="list-style-type: none"> 1. Sketch of repair applies when damage extends over several frames. 2. Isolated fractures may be repaired by veeling-out and rewelding. 3. Isolated cases of grooving may be repaired by build up of welding.

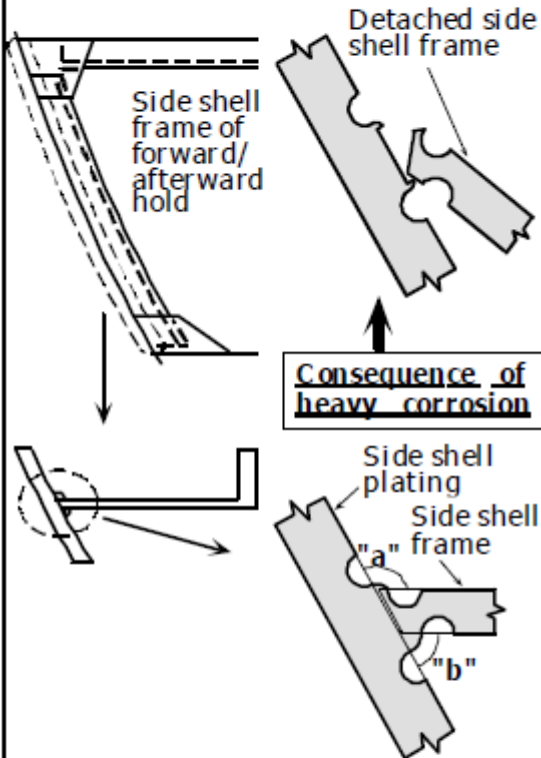
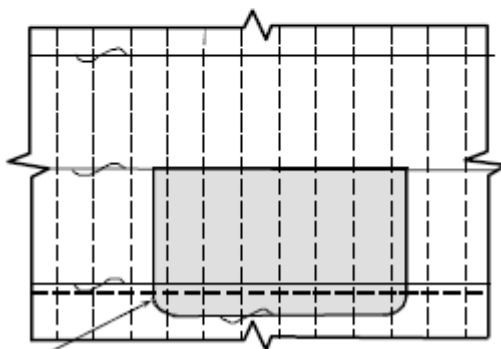
GENERAL CARGO SHIPS		Guidelines for Surveys, Assessment and Repair of Hull Structure
Part 1	Cargo hold region	Example No.
Area 2	Side structure	3
Detail of damage	Adverse effect of corrosion on the frame of forward/afterward hold	
<p>Sketch of damage</p>

<p>Sketch of repair</p>

<ol style="list-style-type: none"> 1. Part renewal including side shell frames and inner bottom plating, as found necessary 2. Deep penetration welding at the connections of side shell frames to side shell plating
<p>Notes on possible cause of damage</p> <p>1. Heavy corrosion (grooving) of side shell frame along side shell plating and difference of throat thickness "a" from "b". (Since original throat thickness of "a" is usually smaller than that of "b", if same welding procedure is applied, the same corrosion has a more severe effect on "a", and may cause collapse and/or detachment of side shell frame.)</p>		<p>Notes on repairs</p> <ol style="list-style-type: none"> 1. Sketch of repair applies when damage extends over several frames. 2. Isolated fractures may be repaired by veeing-out and rewelding. 3. Isolated cases of grooving may be repaired by build up of welding.

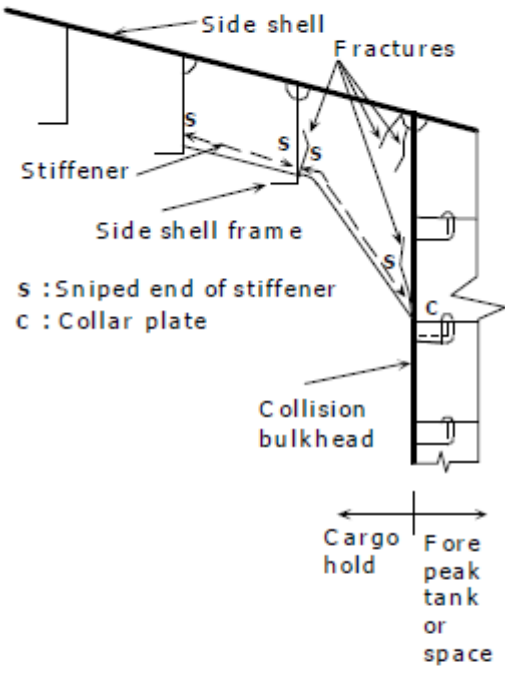
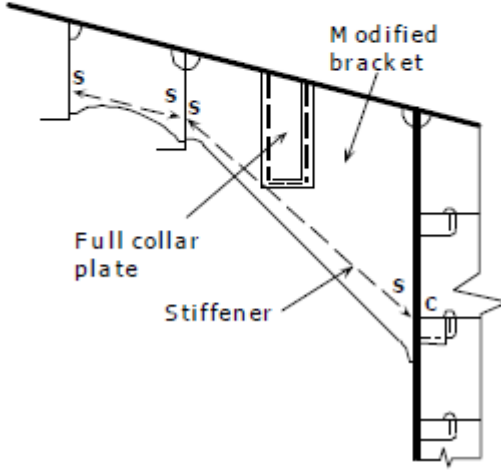
GENERAL CARGO SHIPS		Guidelines for Surveys, Assessment and Repair of Hull Structure
Part 1	Cargo hold region	Example No.
Area 2	Side structure	4
Detail of damage	Fractures at the supporting brackets in way of the collision bulkhead, (with no side shell panting stringers fitted in hold)	
Sketch of damage

Sketch of repair

Notes on possible cause of damage 1. Insufficient bracket size resulting in high stress due to load cantilevered from side frame. 2. Stress concentration at toe of bracket and misalignment between bracket and stringer in fore peak tank or space.		Notes on repairs 1. The extended bracket arm connection to the collision bulkhead is to have a soft toe, and any cut-outs for stiffeners in the fore peak tank or space are to be collared when situated in the vicinity of the bracket toe. 2. When fractures have extended into the side shell or bulkhead plating, the plating is to be cropped and part renewed.

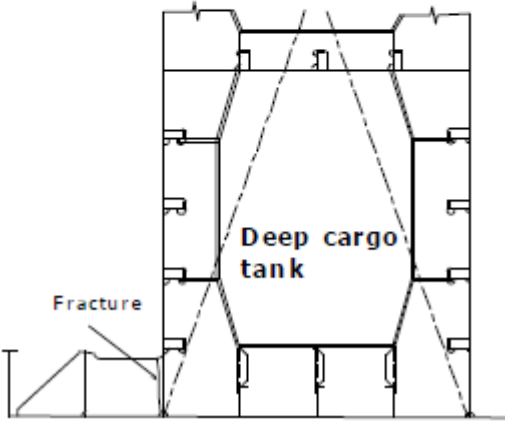
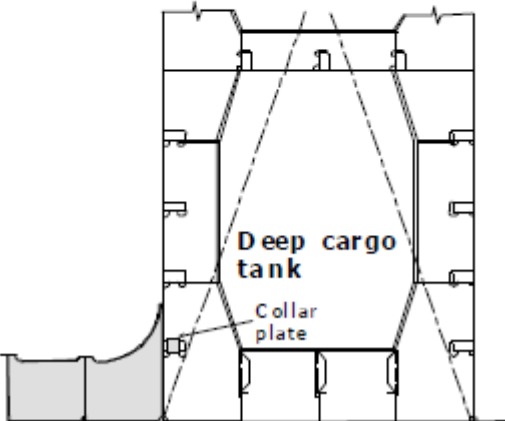
GENERAL CARGO SHIPS		Guidelines for Surveys, Assessment and Repair of Hull Structure
Part 1	Cargo hold region	Example No.
Area 2	Side structure	6
Detail of damage	Fractures in way of continuation/extension brackets at the end of deep cargo tank	
Sketch of damage

Sketch of repair

Notes on possible cause of damage 1. Damage caused by stress concentration leading to fatigue fracture on side shell. This will be exacerbated because of the greater flexibility of the ordinary hold structure in relation to the deep cargo tank structure.		Notes on repairs 1. The fractured shell plate is to be cropped and part renewed as necessary. 2. Brackets should be modified.

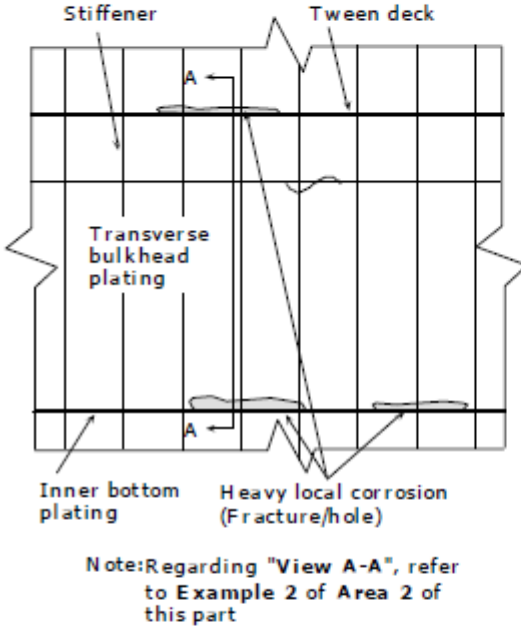
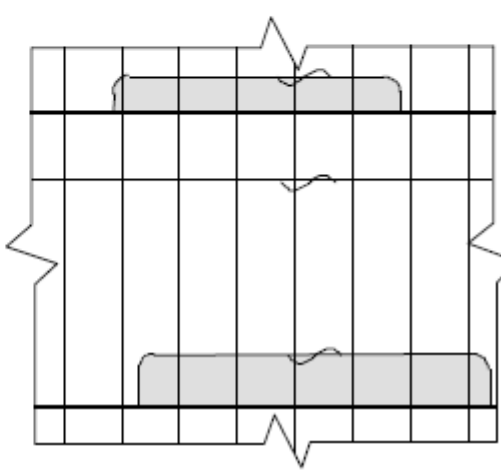
GENERAL CARGO SHIPS		Guidelines for Surveys, Assessment and Repair of Hull Structure
Part 1	Cargo hold region	Example No.
Area 3	Transverse bulkhead structure	1
Detail of damage	Corrosion along inner bottom or tween deck plating	
Sketch of damage

<p>Note: Regarding "View A-A", refer to Example 2 of Area 2 of this part</p>		Sketch of repair

Notes on possible cause of damage 1. Heavy corrosion including grooving along inner bottom plating or tween deck due to poor drainage.		Notes on repairs 1. The extent of the renewal should be determined carefully. If the renewal plate (original thickness) is welded to thin plate (corroded plate), it may cause stress concentration and cause 2. fracture. Protective coating should be applied.

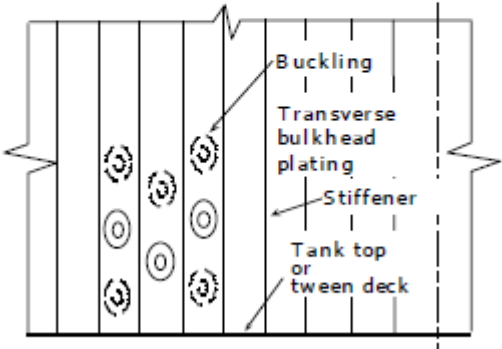
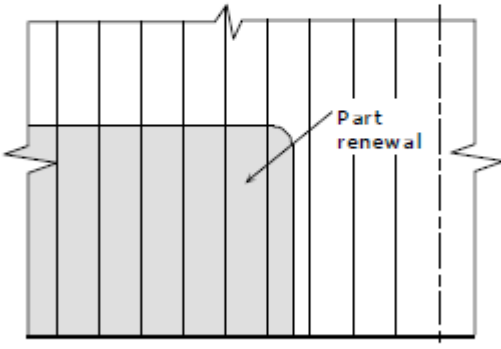
GENERAL CARGO SHIPS		Guidelines for Surveys, Assessment and Repair of Hull Structure
Part 1	Cargo hold region	Example No.
Area 3	Transverse bulkhead structure	2
Detail of damage	Buckling in transverse bulkhead	
Sketch of damage		Sketch of repair

Notes on possible cause of damage 1. Heavy general corrosion.		Notes on repairs 1. The extent of the renewal should be determined carefully. If the renewal plating (original thickness) is welded to thin plating (corroded plating), it may cause stress concentration and fracture. 2. Protective coating should be applied.

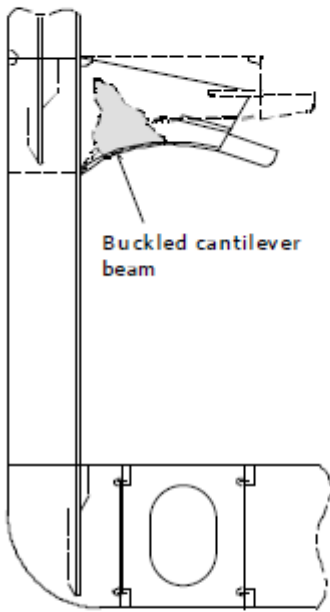
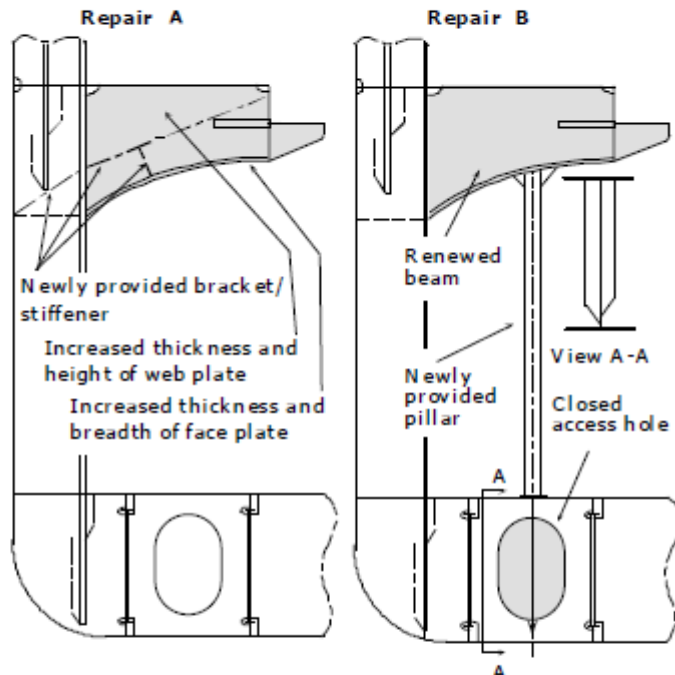
GENERAL CARGO SHIPS		Guidelines for Surveys, Assessment and Repair of Hull Structure
Part 1	Cargo hold region	Example No.
Area 4	Tween deck structure	1
Detail of damage	Sagging of deck panel/buckling of cantilever beam	
Sketch of damage		Sketch of repair

Notes on possible cause of damage		Notes on repairs
<p>1. Poor design, overloading and/or excessive inertia force caused in heavy weather.</p>		<p>1. The affected structures are to be cropped and renewed.</p> <p>2. Repair A: Reinforcement should be considered by increased scantlings of beam and/or additional stiffeners.</p> <p>3. Repair B: Pillars may be provided for reinforcement subject to the approval of the owner. In such a case, reinforcement of the floor under the pillar should be considered. (In the above example, access hole was closed.)</p>

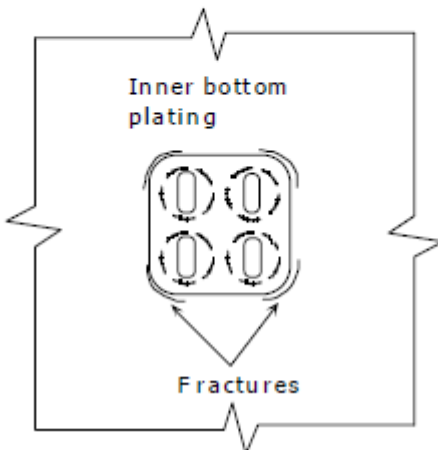
GENERAL CARGO SHIPS		Guidelines for Surveys, Assessment and Repair of Hull Structure
Part 1	Cargo hold region	Example No.
Area 5	Double bottom structure	1
Detail of damage	Fractures in inner bottom plating around container bottom pocket	
Sketch of damage

Notes on possible cause of damage 1. Pocket is not supported correctly by floor, longitudinal and/or stiffener.		Notes on repairs 1. Fractured plating should be cropped and part renewed. 2. Adequate reinforcement should be considered.

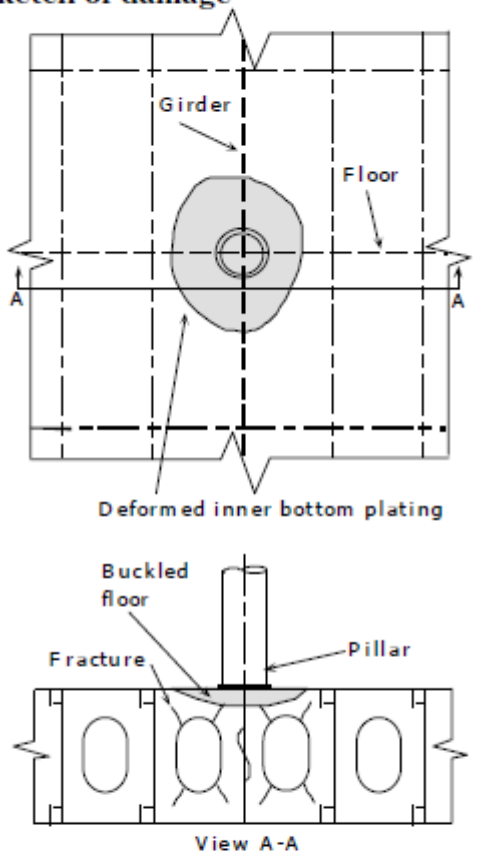
<p>View A-A</p>

GENERAL CARGO SHIPS		Guidelines for Surveys, Assessment and Repair of Hull Structure
Part 1	Cargo hold region	Example No.
Area 5	Double bottom structure	2
Detail of damage	Dented inner bottom plating and buckled/fractured floor under pillar	
Sketch of damage		Sketch of repair

<p>View B-B</p>
Notes on possible cause of damage <ol style="list-style-type: none"> 1. Inadequate arrangement and/or reinforcement of access holes. 2. Excessive deck-loading on tween deck. 		Notes on repairs <ol style="list-style-type: none"> 1. Dented inner bottom plating is to be cropped and part renewed. 2. The fractured floor is to be cropped and part renewed. 3. Access holes should be closed by insert plates. 4. Stiffener on floor/girder and/or brackets should be considered. (Fitting of brackets in the hold is subject to the agreement of the owner.)

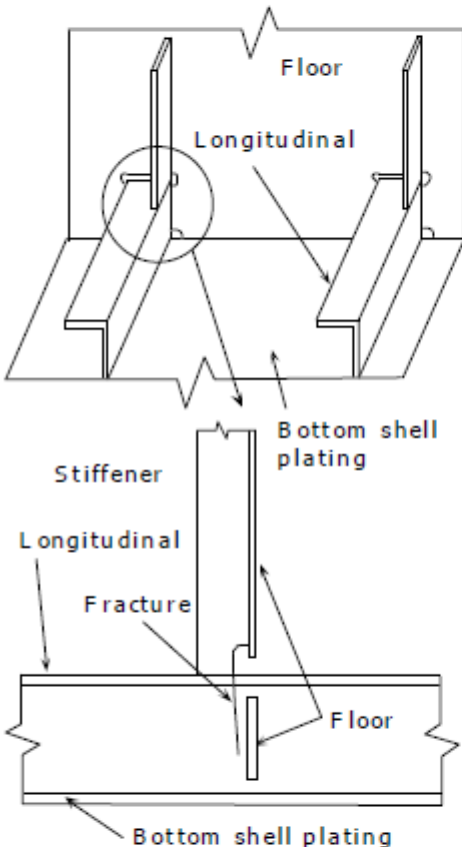
GENERAL CARGO SHIPS		Guidelines for Surveys, Assessment and Repair of Hull Structure
Part 1	Cargo hold region	Example No.
Area 5	Double bottom structure	3-a
Detail of damage	Fractures at the connection of bottom/inner bottom longitudinal to floor stiffener	
Sketch of damage		Sketch of repair

<p>Note: same damage may occur at similar connection to inner bottom plating</p>

Notes on possible cause of damage 1. Damage can be caused by stress concentrations leading to accelerated fatigue in this region.		Notes on repairs 1. If fracture extends to over one third of the depth of the longitudinal, then crop and part renew. Otherwise the fracture can be veed-out and welded.

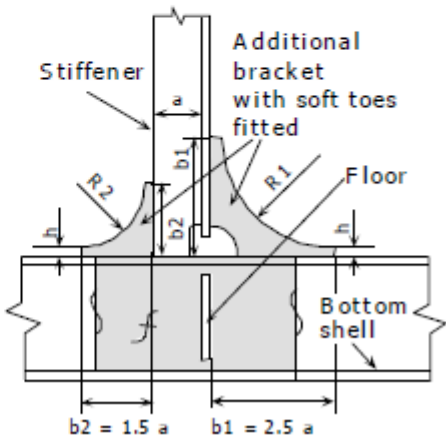
<p>f: Where required, the longitudinal to be cropped and part renewed</p> <ol style="list-style-type: none"> 1. For a slope at toes max. 1 : 3, $R1 = (b1-h) \times 1.6$ and $R2 = (b2-h) \times 1.6$ 2. Soft toe bracket to be welded first to longitudinal 3. Scallop in bracket to be as small as possible, recommended max. 35 mm 4. If toes of brackets are ground smooth, full penetration welds in way to be provided 5. Maximum length to thickness ratio = 50 : 1 for unstiffened bracket edge 6. Toe height, h, to be as small as possible (10- 15 mm)

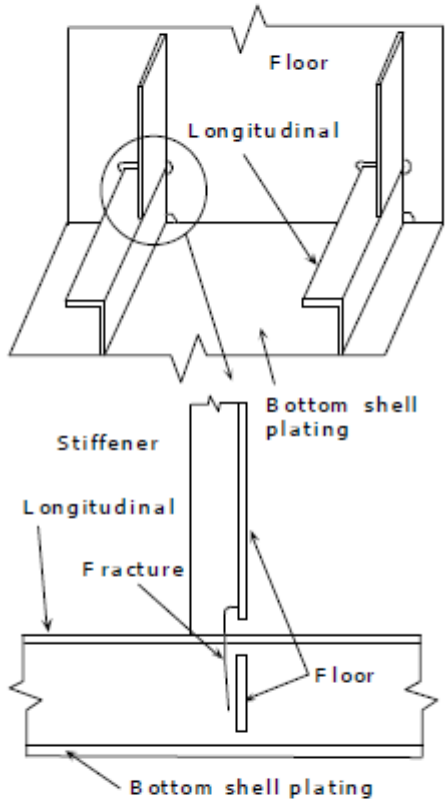
GENERAL CARGO SHIPS		Guidelines for Surveys, Assessment and Repair of Hull Structure
Part 1	Cargo hold region	Example No.
Area 5	Double bottom structure	3-b
Detail of damage	Fractures at the connection of bottom/inner bottom longitudinal to floor stiffener	
Sketch of damage

<p>Note: same damage may occur at similar connection to inner bottom plating</p>		Sketch of repair

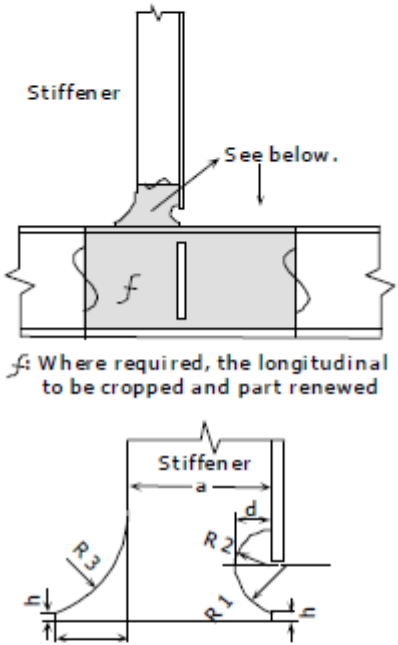
<p>Where required, the longitudinal to be cropped and part renewed</p> <p>Various cut-out shapes have been developed. The following is one example.</p> <ol style="list-style-type: none"> 1. Toe height as small as possible ($h = 10 - 15 \text{ mm}$) 2. Depth "d" of key hole notch as small as possible, max. 30 mm 3. For a slope at toe max. 1 : 3 4. $R1 = 1.5d$, $R2 = d$ and $R3 = 1.5c$
Notes on possible cause of damage 1. Damage can be caused by stress concentrations leading to accelerated fatigue in this region.		Notes on repairs 1. If fracture extends to over one third of the depth of the longitudinal, then crop and part renew. Otherwise the fracture can be veed-out and welded.

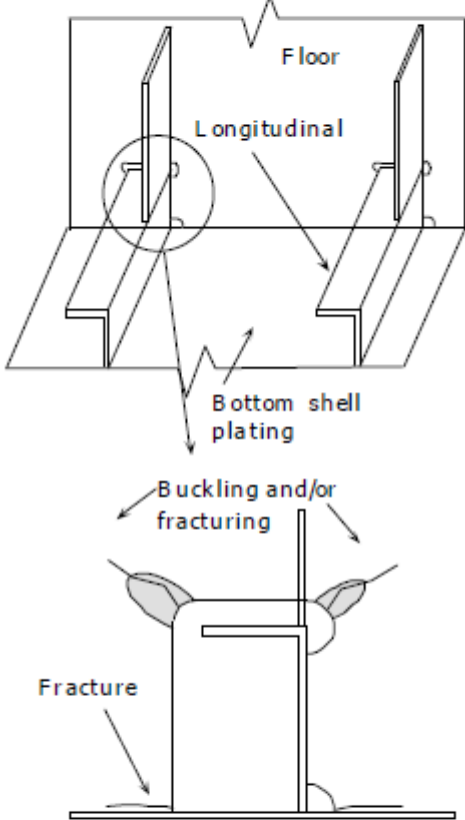
GENERAL CARGO SHIPS		Guidelines for Surveys, Assessment and Repair of Hull Structure
Part 1	Cargo hold region	Example No.
Area 5	Double bottom structure	4
Detail of damage	Fractures and buckling in way of a cut-out for the passage of a longitudinal through a transverse primary member	
Sketch of damage

<p>Note: same type of damage may occur at similar connections to inner bottom</p>		Sketch of repair <p>Repair A</p>

Notes on possible cause of damage 1. Damage can be caused by general levels of corrosion and presence of stress concentration associated with the presence of a cut-out.		Notes on repairs 1. If fractures are significant then crop and part renew the floor plating otherwise the fracture can be veed-out and welded provided the plating is not generally corroded. 2. Repair B is to be incorporated if the lug proves to be ineffective.

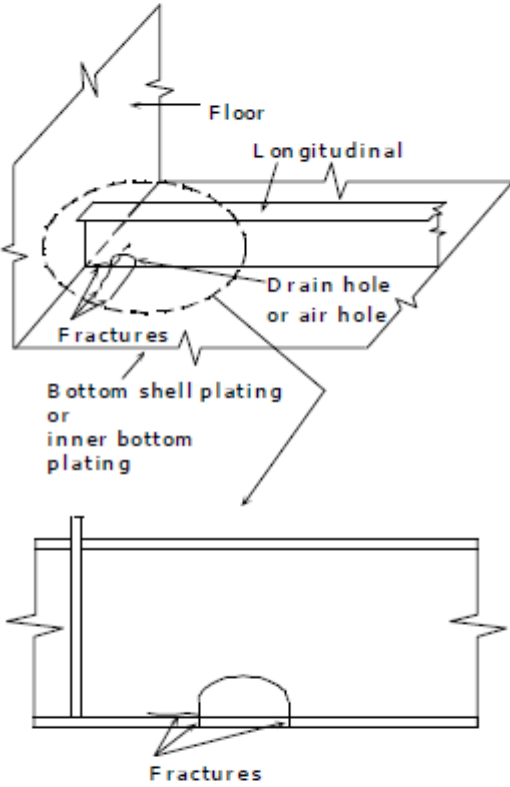
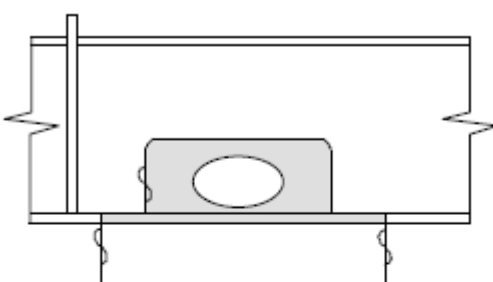
GENERAL CARGO SHIPS		Guidelines for Surveys, Assessment and Repair of Hull Structure	
Part 1	Cargo hold region	Example No.	
Area 5	Double bottom structure	5	
Detail of damage	Fractures in bottom shell plating/inner bottom plating at the corner drain hole/air hole in longitudinal		
Sketch of damage		Sketch of repair

Notes on possible cause of damage		Notes on repairs	
1. Stress concentration and/or corrosion due to stress concentration at the corner of drain hole/air hole.		1. Fractured plating should be cropped and part renewed. 2. If fatigue life is to be improved, change of drain hole/air hole shape is to be considered.

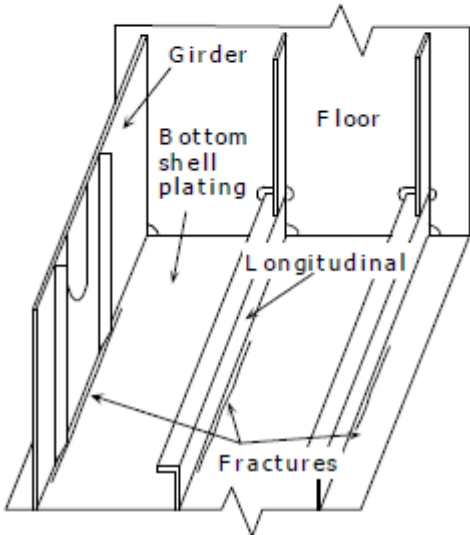
GENERAL CARGO SHIPS		Guidelines for Surveys, Assessment and Repair of Hull Structure
Part 1	Cargo hold region	Example No.
Area 5	Double bottom structure	6
Detail of damage	Fracture in bottom shell plating along side girder and/or bottom longitudinal	
Sketch of damage

Notes on possible cause of damage 1. Vibration.		Notes on repairs 1. Fractured bottom shell plating should be cropped and renewed. 2. Natural frequency of the panel should be changed, e.g. reinforcement by additional stiffener/bracket.

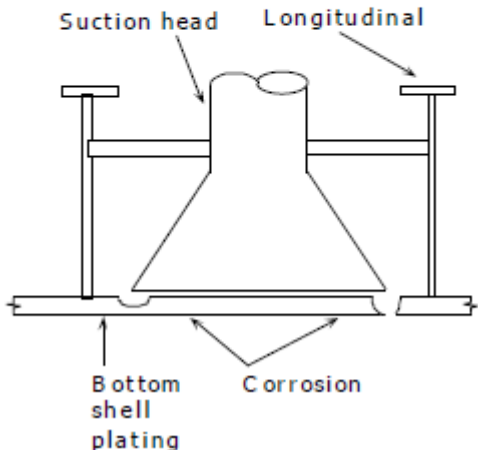
GENERAL CARGO SHIPS		Guidelines for Surveys, Assessment and Repair of Hull Structure
Part 1	Cargo hold region	Example No.
Area 5	Double bottom structure	7
Detail of damage	Corrosion in bottom plating below suction head	
Sketch of damage

<ol style="list-style-type: none"> 1. Insert to have round corners 2. Non-destructive examination to be applied after welding based on the Society's rules
Notes on possible cause of damage <ol style="list-style-type: none"> 1. High flow rate associated with insufficient corrosion prevention system. 2. Galvanic action between dissimilar metals 		Notes on repairs <ol style="list-style-type: none"> 1. Affected plating should be cropped and part renewed. Thicker plate and suitable beveling should be considered. 2. If the corrosion is limited to a small area, i.e. pitting corrosion, repair by welding is acceptable.

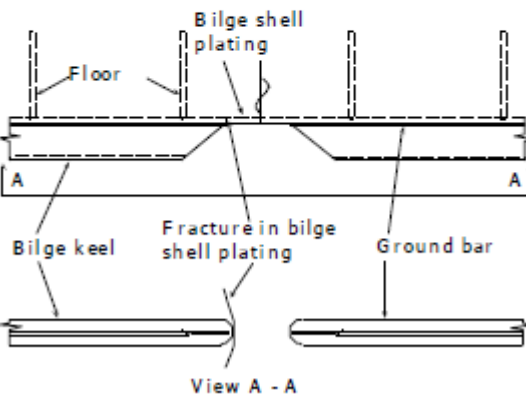
GENERAL CARGO SHIPS		Guidelines for Surveys, Assessment and Repair of Hull Structure
Part 1	Cargo hold region	Example No.
Area 5	Double bottom structure	8
Detail of damage	Fracture in shell plating at the termination of bilge keel	
Sketch of damage

Notes on possible cause of damage 1. Poor design causing stress concentration.		Notes on repairs 1. Fractured plating is to be cropped and renewed. 2. Reduction of stress concentration of the bilge keel end should be considered. Repair A: Modification of the detail of end Repair B: New internal stiffeners 3. Instead of Repair A or B continuous ground bar and bilge keel should be considered.

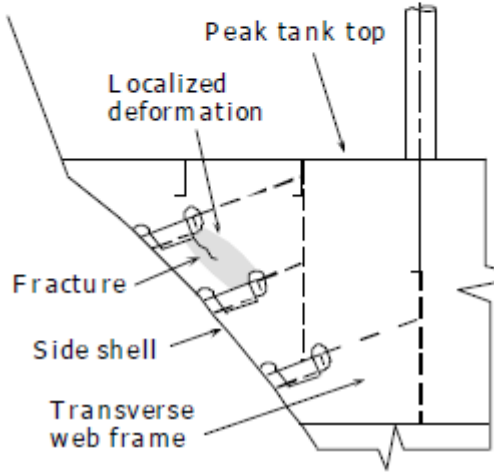
Guidelines for Surveys, Assessment and Repair of Hull Structure		
Part 2	Fore and aft end regions	Example No.
Area 1	Fore end structure	1
Detail of damage	Fracture and deformation of bow transverse web in way of cut-outs for side longitudinals	
Sketch of damage

Notes on possible cause of damage 1. Localized material wastage in way of coating failure at cut-outs and sharp edges due to working of the structure. 2. Dynamic seaway loading in way of bow flare.		Notes on repairs 1. Sufficient panel strength to be provided to absorb the dynamic loads enhanced by bow flare shape.

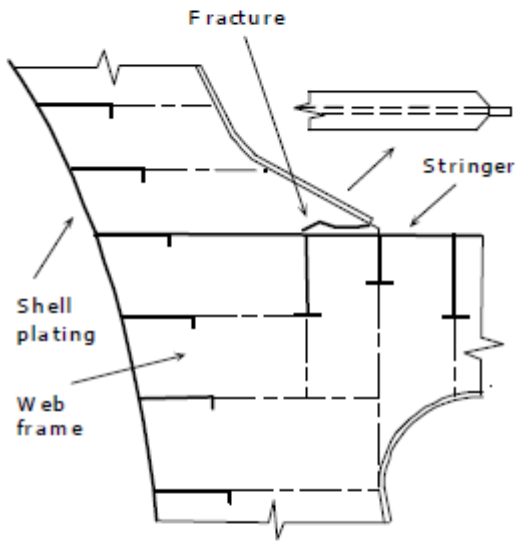
Guidelines for Surveys, Assessment and Repair of Hull Structure		
Part 2	Fore and aft end regions	Example No.
Area 1	Fore end structure	2
Detail of damage	Fracture at toe of web frame bracket connection to stringer platform bracket	
Sketch of damage

Notes on possible cause of damage <ol style="list-style-type: none"> 1. Inadequate bracket forming the web frame connection to the stringer. 2. Localized material wastage in way of coating failure at bracket due to flexing of the structure. 3. Dynamic seaway loading in way of bow flare. 		Notes on repairs <ol style="list-style-type: none"> 1. Adequate soft nose bracket endings with a face plate taper of at least 1 : 3 to be provided.

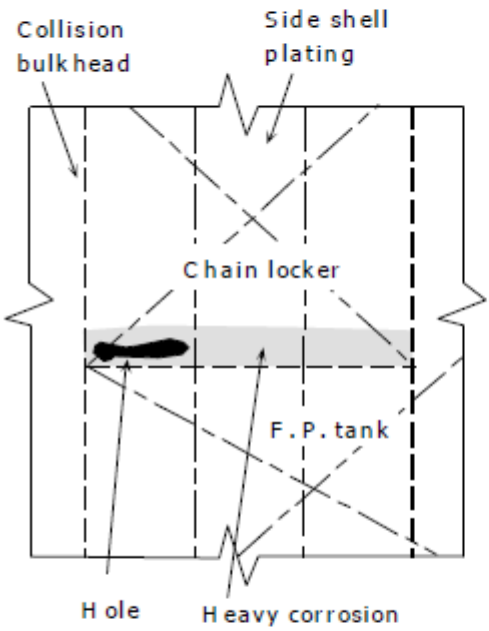
Guidelines for Surveys, Assessment and Repair of Hull Structure		
Part 2	Fore and aft end regions	Example No.
Area 1	Fore end structure	3
Detail of damage	Fracture in side shell plating in way of chain locker	
Sketch of damage

Notes on possible cause of damage 1. Heavy corrosion in region where mud is accumulated.		Notes on repairs 1. Corroded plating should be cropped and renewed. 2. Protective coating should be applied.

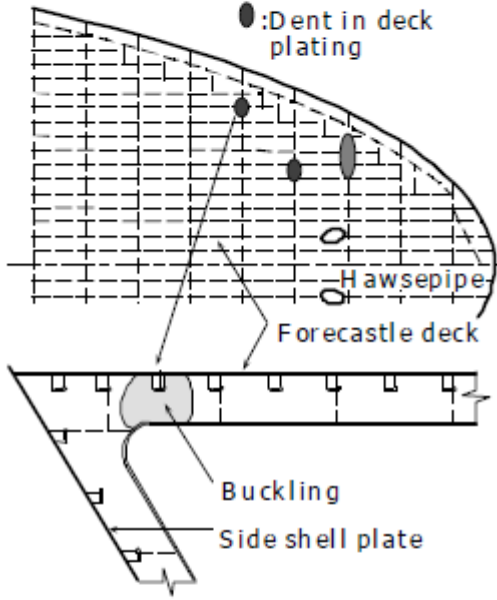
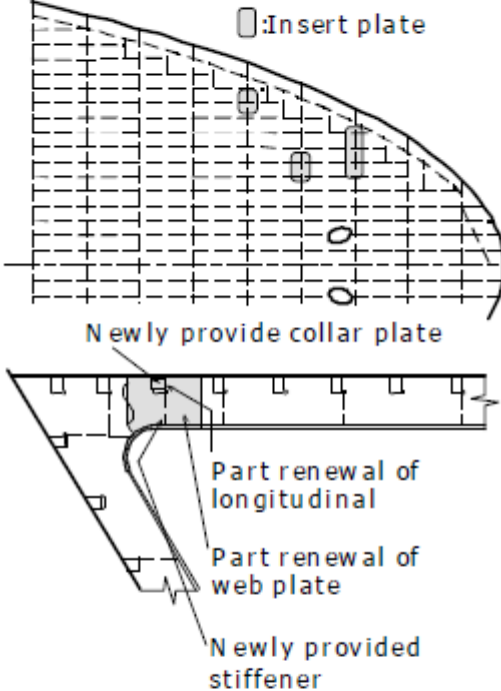
Guidelines for Surveys, Assessment and Repair of Hull Structure		
Part 2	Fore and aft end regions	Example No.
Area 1	Fore end structure	4
Detail of damage	Deformation of forecastle deck	
Sketch of damage		Sketch of repair

Notes on possible cause of damage 1. Green sea on deck. 2. Insufficient strength.		Notes on repairs 1. Deformed structure should be cropped and renewed. 2. Additional stiffeners on web of beam should be considered for reinforcement.

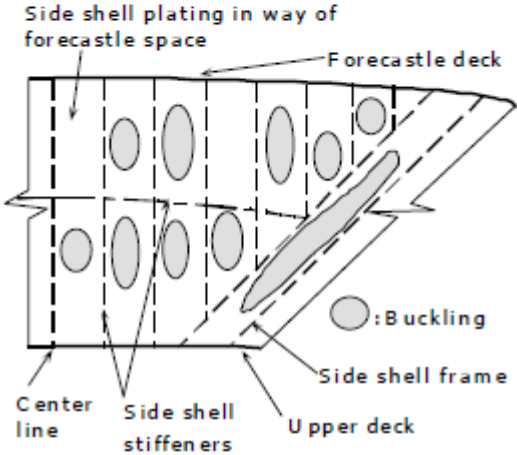
Guidelines for Surveys, Assessment and Repair of Hull Structure		
Part 2	Fore and aft end regions	Example No.
Area 1	Fore end structure	5
Detail of damage	Deformation of side shell plating in way of forecastle space	
Sketch of damage

<p>Side shell plating in way of forecastle space</p> <p>Forecastle deck</p> <p>Buckling</p> <p>Center line</p> <p>Side shell stiffeners</p> <p>Side shell frame</p> <p>Upper deck</p>		Sketch of repair

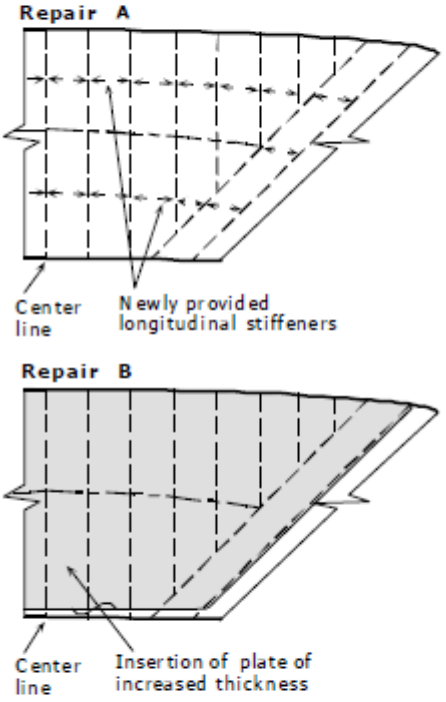
<p>Repair A</p> <p>Center line</p> <p>Newly provided longitudinal stiffeners</p> <p>Repair B</p> <p>Center line</p> <p>Insertion of plate of increased thickness</p>
Notes on possible cause of damage 1. Heavy weather. 2. Insufficient strength.		Notes on repairs 1. Deformed part should be cropped and part renewed. 2. Repair A Additional stiffeners between existing stiffeners should be considered. Repair B Insertion of plate of increased thickness with additional stiffeners

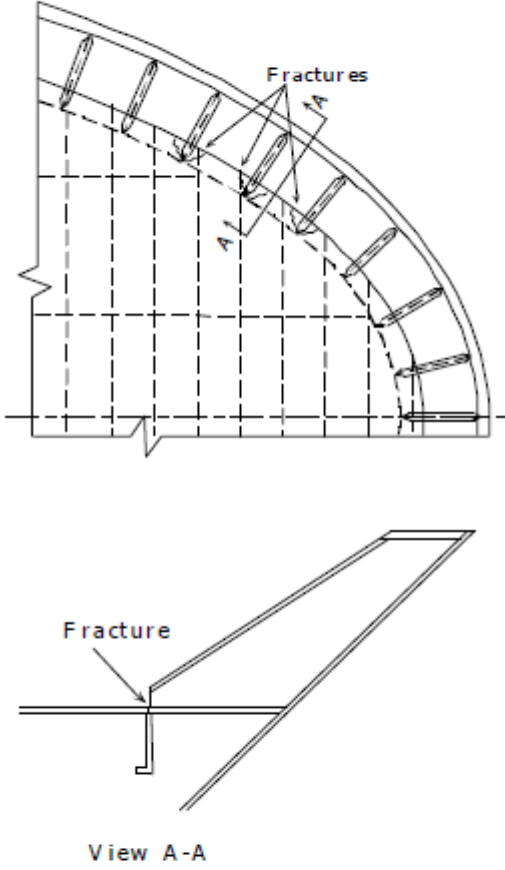
Guidelines for Surveys, Assessment and Repair of Hull Structure		
Part 2	Fore and aft end regions	Example No.
Area 1	Fore end structure	6
Detail of damage	Fracture in forecastle deck plating at bulwark	
Sketch of damage		Sketch of repair

<p>Fractures</p> <p>Fracture</p> <p>View A-A</p>

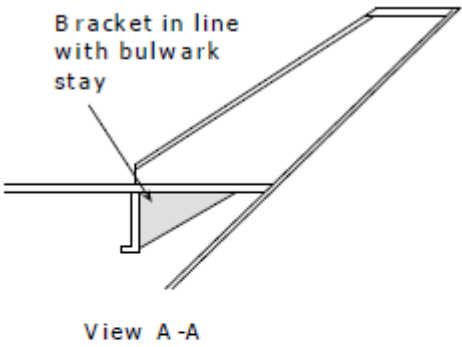
<p>Bracket in line with bulwark stay</p> <p>View A-A</p>
Notes on possible cause of damage <ol style="list-style-type: none"> 1. Bow flare effect in heavy weather. 2. Stress concentration due to poor design. 		Notes on repairs <ol style="list-style-type: none"> 1. Fractured deck plating should be cropped and renewed. 2. Bracket in line with the bulwark stay to be fitted to reduce stress concentration.

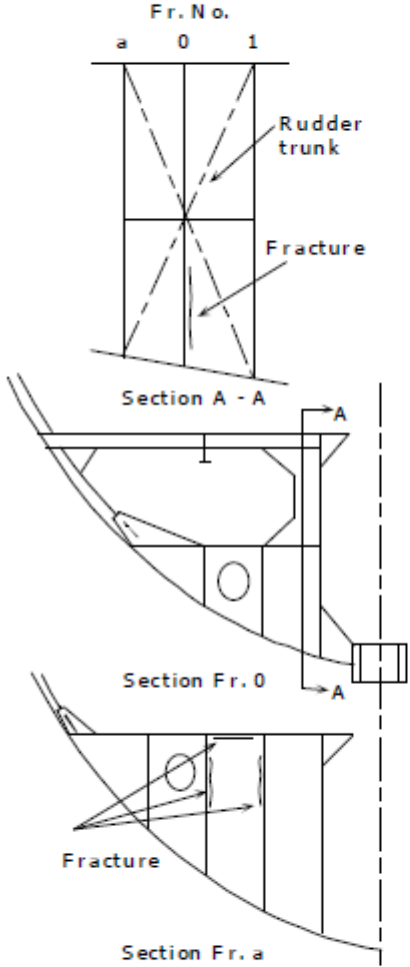
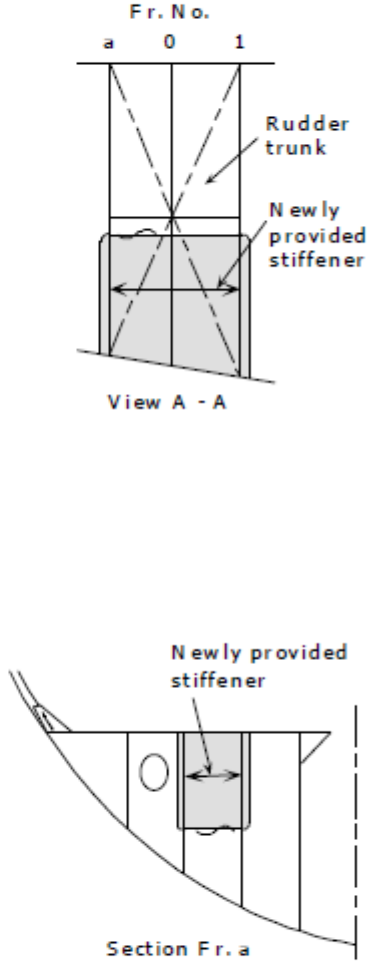
Guidelines for Surveys, Assessment and Repair of Hull Structure		
Part 2	Fore and aft end regions	Example No.
Area 2	Aft end structure	1
Detail of damage	Fractures in bulkhead in way of rudder trunk	
Sketch of damage		Sketch of repair

Notes on possible cause of damage		Notes on repairs
1. Vibration.		1. The fractured plating should be cropped and renewed. 2. Natural frequency of the plate between stiffeners should be changed, e.g. reinforcement by additional stiffeners.

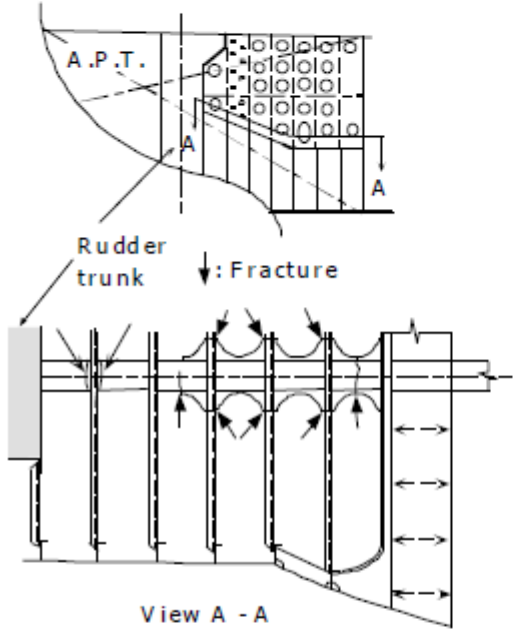
Guidelines for Surveys, Assessment and Repair of Hull Structure		
Part 2	Fore and aft end regions	Example No.
Area 2	Aft end structure	2
Detail of damage	Fractures at the connection of floors and girders/side brackets	
Sketch of damage

Notes on possible cause of damage 1. Vibration.		Notes on repairs 1. The fractured plating should be cropped and renewed. 2. Natural frequency of the panel should be changed, e.g. reinforcement by additional strut.

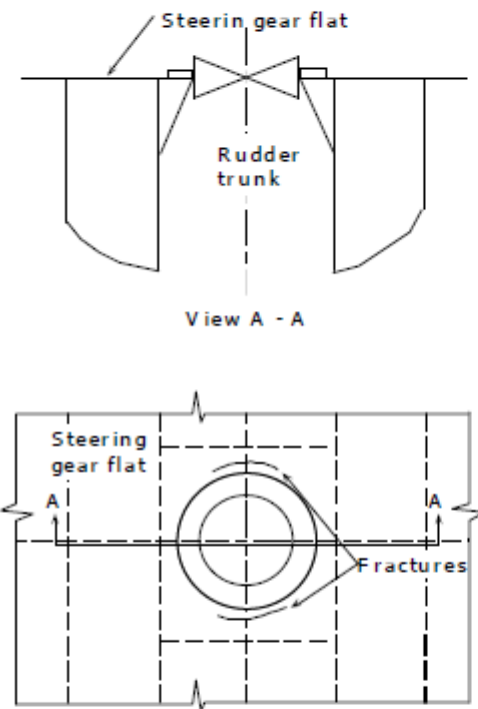
Guidelines for Surveys, Assessment and Repair of Hull Structure		
Part 2	Fore and aft end regions	Example No.
Area 2	Aft end structure	3-a
Detail of damage	Fracture in flat where rudder carrier is installed in steering gear room	
Sketch of damage		Sketch of repair

<p>Steering gear flat</p> <p>Rudder trunk</p> <p>View A - A</p> <p>Steering gear flat</p> <p>Fractures</p>

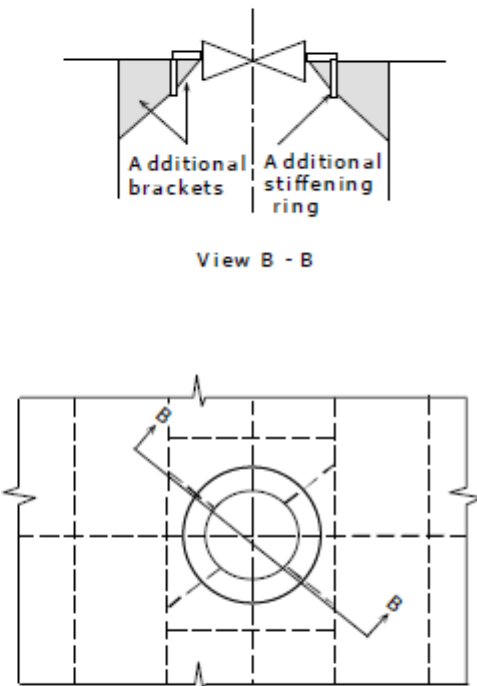
<p>Additional brackets</p> <p>Additional stiffening ring</p> <p>View B - B</p>
Notes on possible cause of damage		Notes on repairs
1. Inadequate design.		1. Fractured plating should be cropped and renewed. 2. Additional brackets and stiffening ring should be fitted for reinforcement.

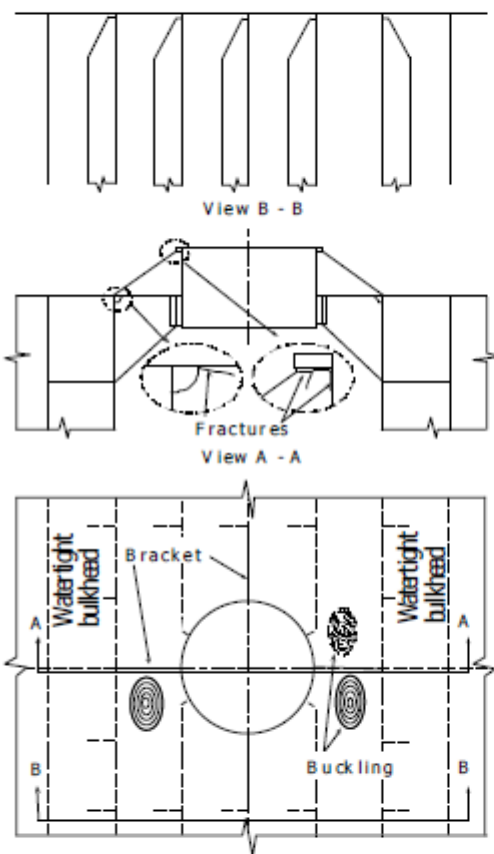
Guidelines for Surveys, Assessment and Repair of Hull Structure		
Part 2	Fore and aft end regions	Example No.
Area 2	Aft end structure	3-b
Detail of damage	Fractures in steering gear foundation brackets and deformed deck plate	
Sketch of damage

Notes on possible cause of damage 1. Insufficient deck strengthening (missing base plate). 2. Insufficient strengthening of steering gear foundation. 3. Bolts of steering gear were not sufficiently pre-loaded.		Notes on repairs 1. New insert base plate of increased plate thickness. 2. Additional longitudinal stiffening at base plate edges. 3. Additional foundation brackets above and under deck (star configuration).

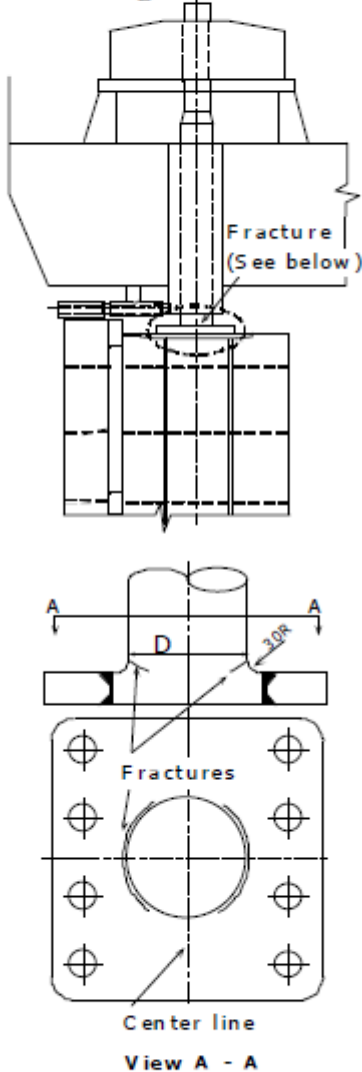
Guidelines for Surveys, Assessment and Repair of Hull Structure		
Part 2	Fore and aft end regions	Example No.
Area 3	Stern frame, rudder arrangement and propeller shaft support	1
Detail of damage	Fracture in rudder stock	
Sketch of damage		Sketch of repair

<p>Fracture (See below)</p> <p>Center line View A - A</p>

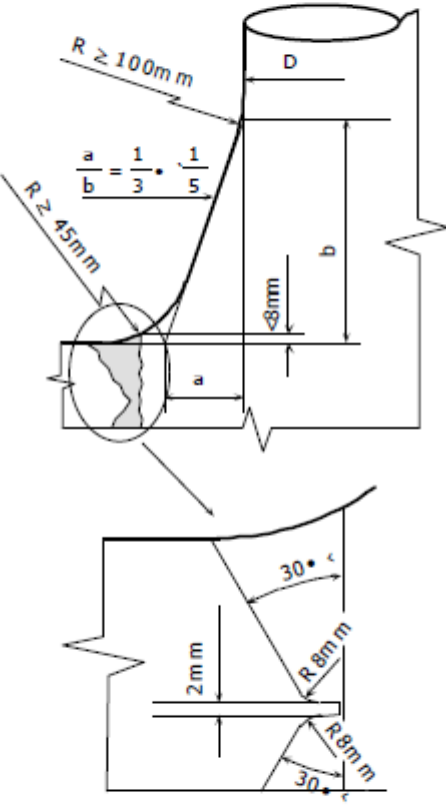
<p>$R \geq 100\text{mm}$</p> <p>$\frac{a}{b} = \frac{1}{3} \cdot \frac{1}{5}$</p> <p>$R \geq 45\text{mm}$</p> <p>$8\text{mm}$</p> <p>$30^\circ$</p> <p>$R 8\text{mm}$</p> <p>$2\text{mm}$</p> <p>$30^\circ$</p>
Notes on possible cause of damage		Notes on repairs
1. Inadequate design for stress concentration in rudder stock.		1. Modification of detail design of rudder stock to reduce the stress concentration.

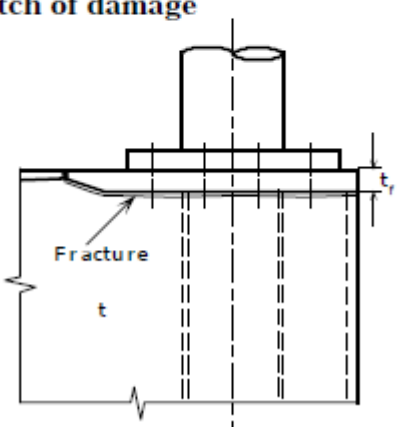
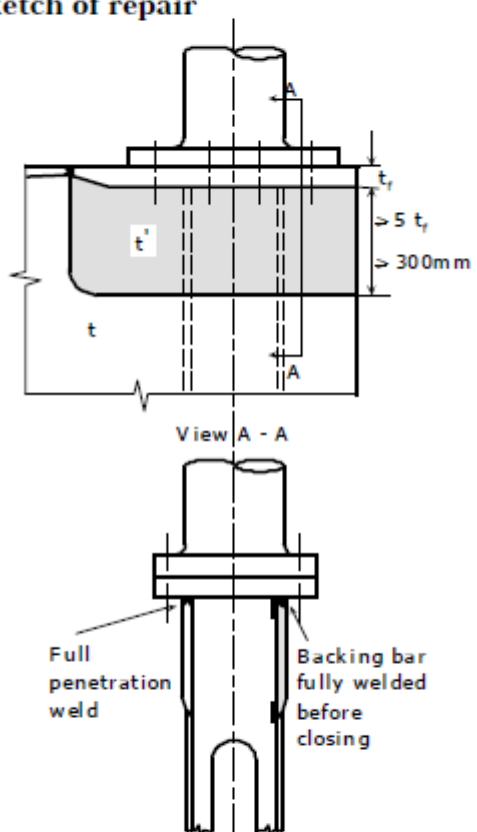
Guidelines for Surveys, Assessment and Repair of Hull Structure		
Part 2	Fore and aft end regions	Example No.
Area 3	Stern frame, rudder arrangement and propeller shaft support	2
Detail of damage	Fracture in connection of palm plate to rudder blade	
Sketch of damage		Sketch of repair

<p>View A - A</p> <p>Full penetration weld</p> <p>Backing bar fully welded before closing</p> <p> t = plate thickness, mm t_r = actual flange thickness, mm $t' = \frac{t_r}{3} + 5$, mm, where $t_r < 50$ mm $t' = 3 \sqrt{t_r}$, mm, where $t_r > 50$ mm </p>
Notes on possible cause of damage 1. Inadequate connection between palm plate and rudder blade plating (insufficient plating thickness and/or insufficient fillet weld).		Notes on repairs 1. Modification of detail design of the connection by increasing the plate thickness and full penetration welding.

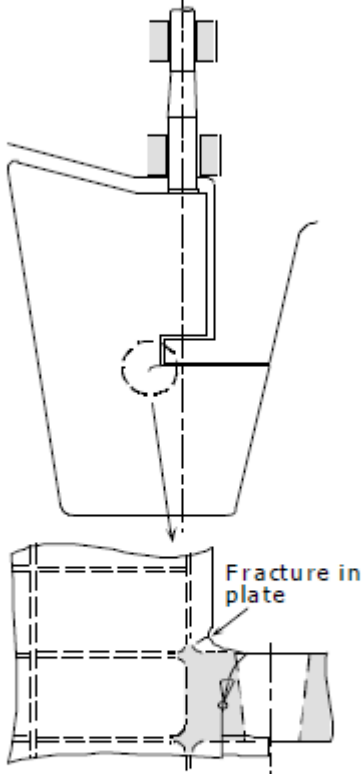
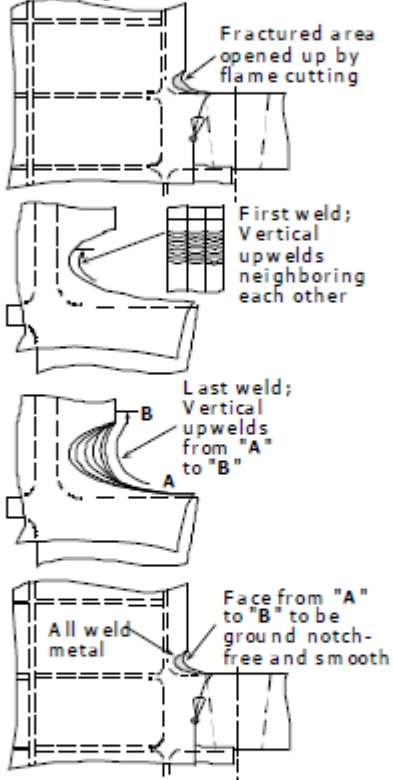
Guidelines for Surveys, Assessment and Repair of Hull Structure		
Part 2	Fore and aft end regions	Example No.
Area 3	Stern frame, rudder arrangement and propeller shaft support	3
Detail of damage	Fracture in rudder plating of semi-spade rudder (short fracture with end located forward of the vertical web)	
Sketch of damage		Sketch of repair

Notes on possible cause of damage		Notes on repairs
<ol style="list-style-type: none"> 1. Stress concentration due to inadequate local design and/or fabrication notches in way of the butt weld between cast piece and plating. 		<ol style="list-style-type: none"> 1. Grooving-out and welding of the fracture is not always adequate (metallurgical notch in way of a high stressed area). 2. In the proposed repair procedure the metallurgical notches are shifted into a zone exposed to lower stresses. 3. After welding a modification of the radius according to the proposal in Example 5 is to be carried out. 4. In case of very small crack it can be ground off by increasing the radius.

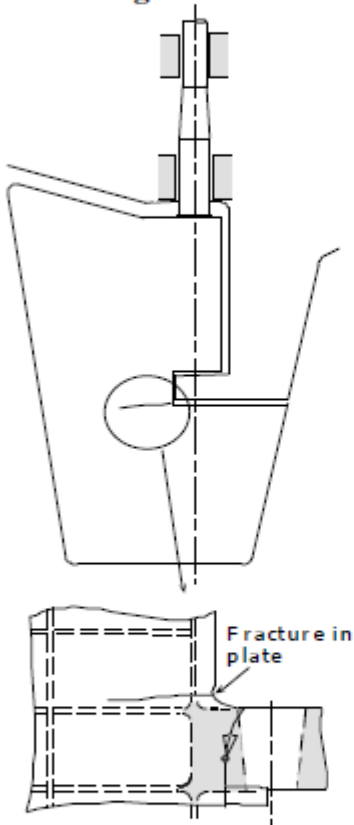
Guidelines for Surveys, Assessment and Repair of Hull Structure		
Part 2	Fore and aft end regions	Example No.
Area 3	Stern frame, rudder arrangement and propeller shaft support	4
Detail of damage	Fracture in rudder plating of semi-spade rudder extending beyond the vertical web	
Sketch of damage		Sketch of repair

<p>Fracture in plate</p>

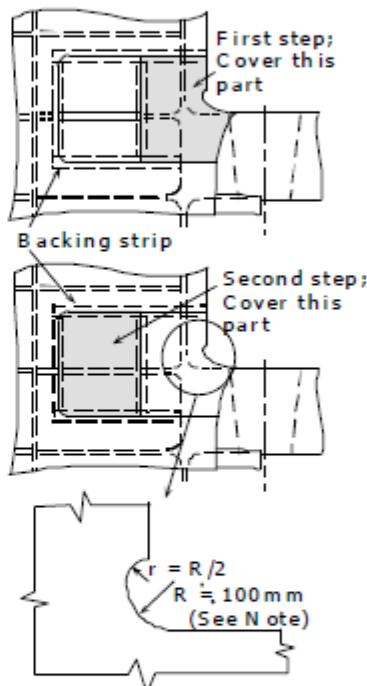
<p>First step; Cover this part</p> <p>Backing strip</p> <p>Second step; Cover this part</p> <p>$r = R/2$ $R \approx 100 \text{ mm}$ (See Note)</p> <p>Note: R should be considered according to local detail</p>
Notes on possible cause of damage		Notes on repairs
<ol style="list-style-type: none"> 1. Stress concentration due to inadequate local design and/or fabrication notches in way of the butt weld between cast piece and plating. 		<ol style="list-style-type: none"> 1. Fractured plating is to be cut-out. 2. Internal structures are to be checked. 3. Cut-out is to be closed by an insert plating according to the sketch (welding only from one side is demonstrated). 4. Modification of the radius. 5. In case of a new cast piece, connection with the plating is to be shifted outside the high stress area.

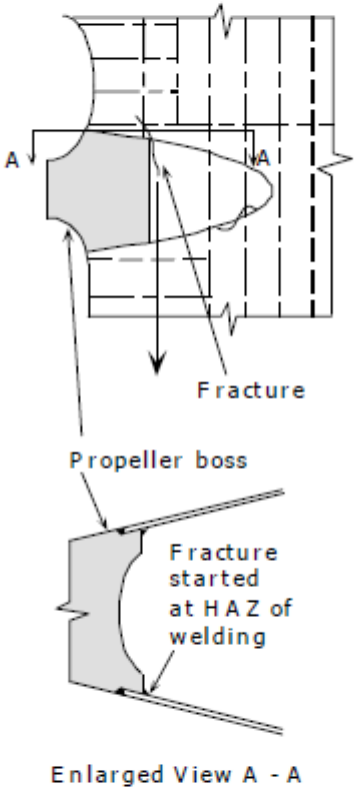
Guidelines for Surveys, Assessment and Repair of Hull Structure		
Part 2	Fore and aft end regions	Example No.
Area 3	Stern frame, rudder arrangement and propeller shaft support	6
Detail of damage	Fracture in side shell plating at the connection to propeller boss	
Sketch of damage		Sketch of repair

<p>Enlarged View A - A</p>

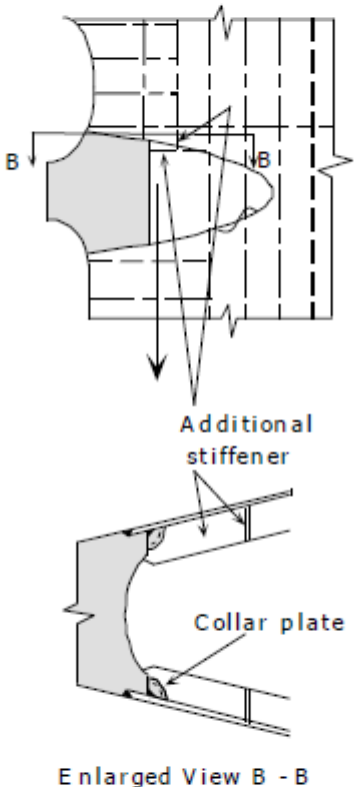
<p>Enlarged View B - B</p>
Notes on possible cause of damage 1. Fatigue fracture due to vibration.		Notes on repairs 1. Fractured side shell plating is to be cropped and part renewed. 2. Additional stiffeners are to be provided. 3. Collar plate is to be provided.

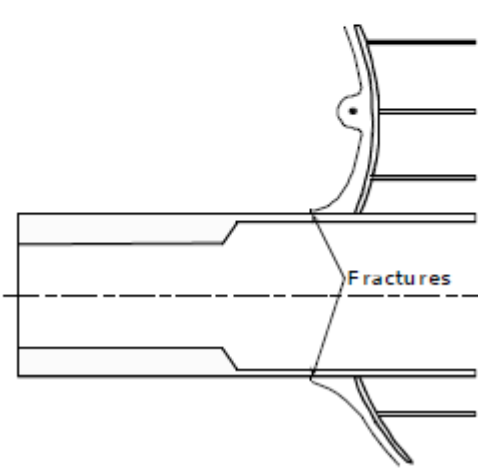
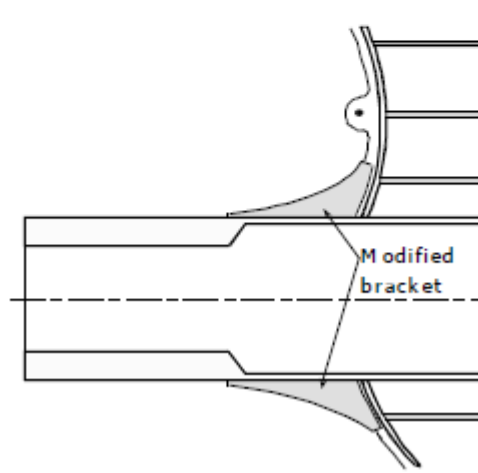
Guidelines for Surveys, Assessment and Repair of Hull Structure		
Part 2	Fore and aft end regions	Example No.
Area 3	Stern frame, rudder arrangement and propeller shaft support	7
Detail of damage	Fracture in stern tube at the connection to stern frame	
Sketch of damage		Sketch of repair

Notes on possible cause of damage 1. Fatigue fracture due to vibration.		Notes on repairs 1. Fractured tube is to be welded from both sides. 2. Brackets are to be replaced by modified brackets with soft transition.
